RESERVE FUND STUDY

Victorian Estates

Halifax County Condominium Corporation No. 241

SITE ASSESSMENT ON:

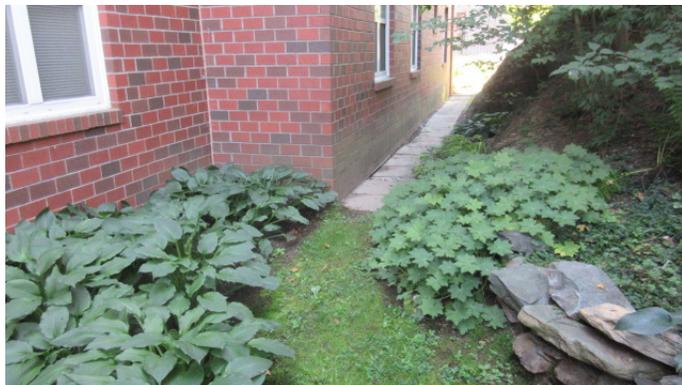
Grades at the west corner and northwest side of the building are at or above the lowest course of brickwork, and without positive drainage away from the building (photo). The area is damp, but no moisture ingress is reported.

A budget for regrading this area, if required, is included with the site contingency allowance.

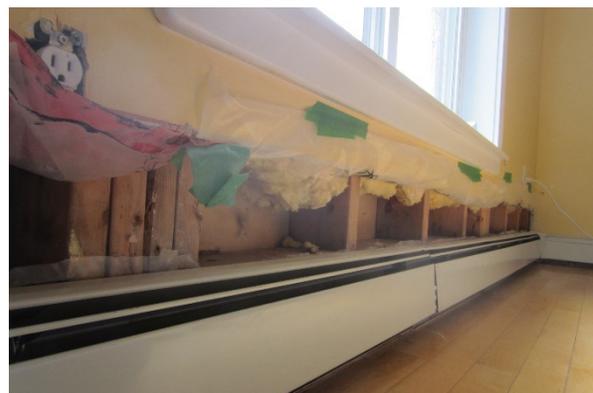
Exterior walls are typically 2x6 wood frame construction with ½" plywood sheathing (photo – Aug. 2013). The roof has pre-engineered wood trusses and sheathing, with insulation supported on ceilings.

In general, the structure is in good condition overall with no evidence of excessive settlement,

deflection or vibration observed or reported. Properly maintained, the framing is assessed to have an indefinite useful life. Any repairs are included in the **Structure – Contingency Allowance** below.

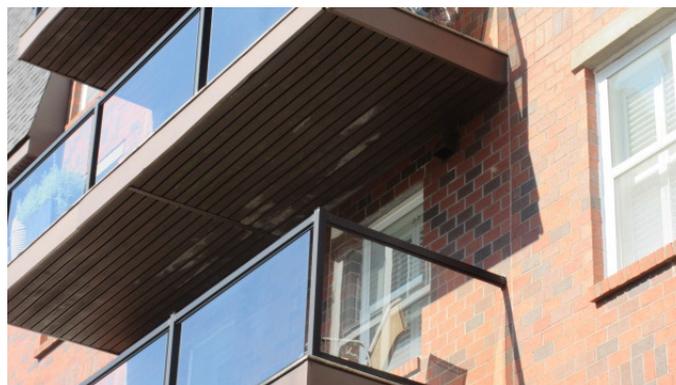
There are 33 balconies which are cantilevered from the building wood framing (photo) and one deck which is supported by the entrance canopy. The balconies have wood decks and framing, metal edge trim and soffits, and metal-framed glazed railings.

The balconies are in good condition overall. Railings are expected to have a life of more than 50 years with routine annual inspection and replacement of components due to local damage. Metal cladding and soffits may have an average life of 40 years – some exhibit loss of paint coating and local damage currently. Decks are assessed to have an average life of 30 years. The service life of cantilevered wood is expected to vary with exposure to and retention of moisture. Local repairs were carried out to wood framing on the northeast elevation to shed water in the brick void in 2007-2008; no issues are reported currently.

A budgetary allowance is recommended based on the replacement of trim and soffit within ten years, and wood decks within 15 years. The budgets include local repairs and replacements to wood framing and railings as found during soffit and deck replacements. The actual scope and timing is to be planned based on more detailed observations closer to the time that the work is required.

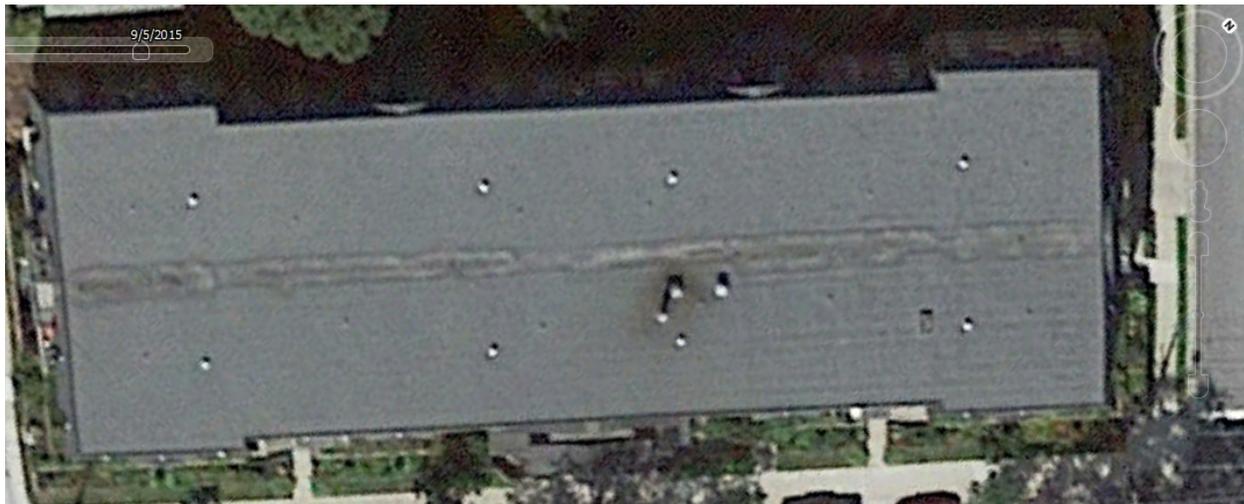
Figure 2 - Satellite image of roof, September 5th, 2015, courtesy Google Earth

As shown in the satellite images in Figure 1 above and Figure 2 below, the main roof system includes a near-flat roofing membrane with little or no perimeter parapet and internal drains along the southwest-northeast axis of the building. The roof membrane is a two-ply modified bitumen system². The membrane is fastened and/or adhered to oriented strand board (OSB)

Roof penetrations include roof vents and vents for a heat recovery ventilator. Three attic hatches were noted but no roof hatch was found. The satellite images indicate water is often retained along the centre of the roof.

The budget includes the addition of a roof hatch and replacement of perimeter flashing.

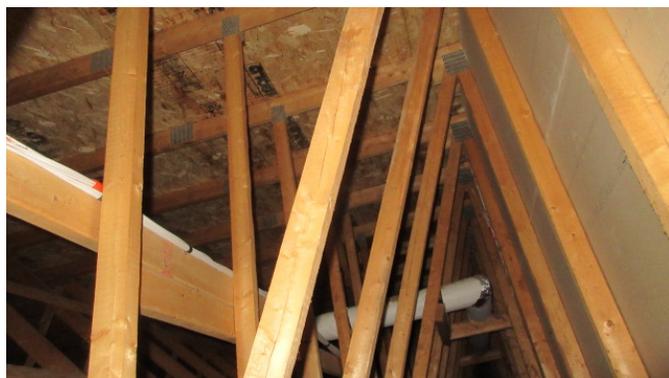
sheathing, with pre-engineered wood trusses and ceiling insulation (photo).

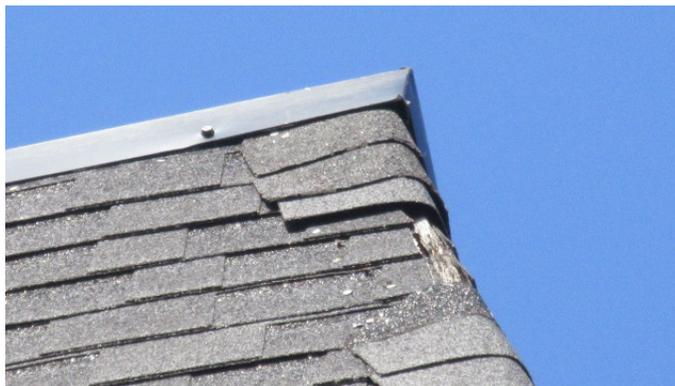
Mansard-style roofs surround the building at the fourth floor. The mansards are in fair condition: while the main areas of shingles are in good condition, several corner shingles are missing (photo) and edge flashings are deformed locally.

The budget proposed in 2013 for repairs and inspections every 3-5 years is carried in this report.

(mansard roof – inspections and repairs: \$12,000; 2018; five-year cycle)
