RESERVE FUND STUDY

277 Rutledge Street

Halifax County Condominium Corporation No. 276

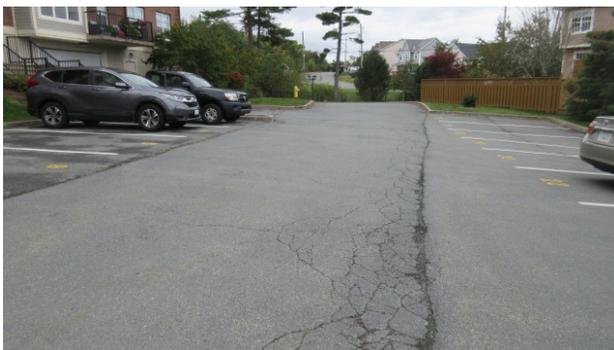
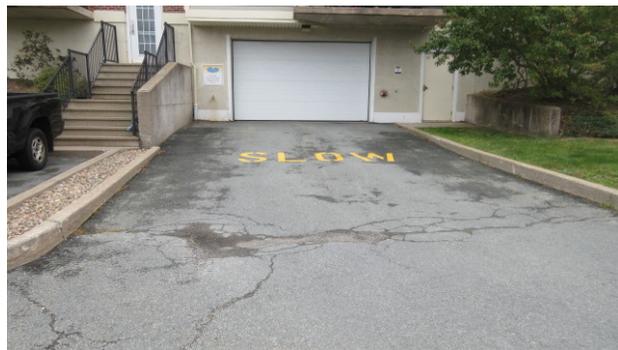
Assessment: The driveway is in good condition overall; the parking area is in fair condition with longitudinal and transverse cracks (photos) and local settlement at parking stalls. The area may remain serviceable for several years but will continue to deteriorate.

Recommendation: replace all paving as funds permit, within 5-10 years. The replacement

(asphalt pavement - replacement: \$84,000; 2025; 30 year cycle)

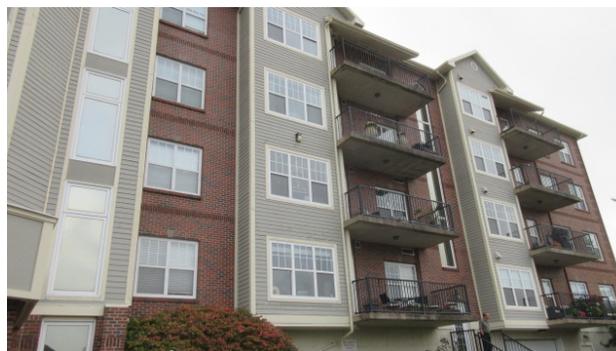
The balconies are 'free cantilever' extensions of the concrete floors. All balconies have aluminum railings which are fastened to the concrete balcony and adjacent walls (photo).

Assessment: The balconies and railings appear to be in good condition overall

Recommendation: budget for recoating all railings within five years as funding permits; include an allowance for pressure washing of floors and for railing inspection and repairs to connection fasteners.

(balcony railings – refurbish and paint: \$36,000; 2022; 15 year cycle)

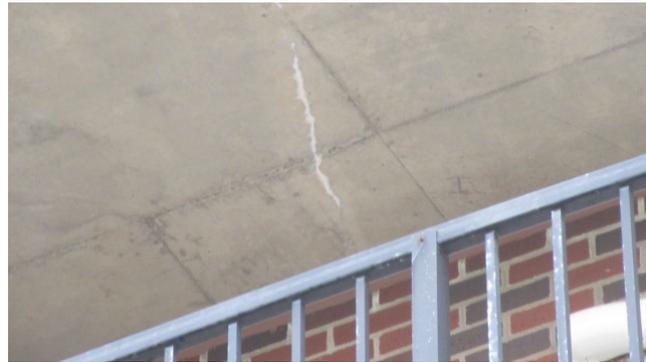
except for wear of the original paint coatings. There are no structural concerns reported. Through-floor moisture is suspected at one location where staining of the underside of balcony was noted (photo).

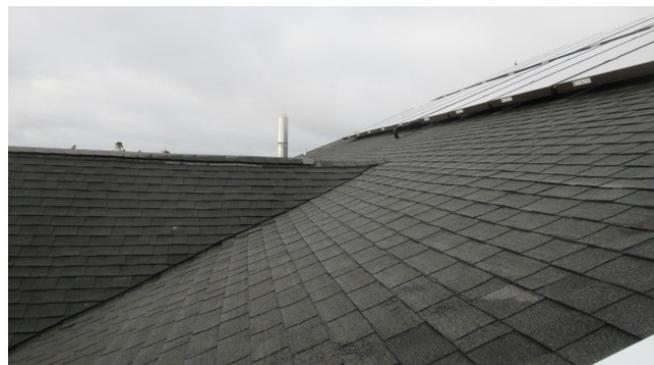
Assessment: The assessment was limited to the east elevation and portions of the attic space. No leaks were reported in the main roof field. There is shingle wear in areas used to access and install roof-mounted solar panels (photo); otherwise, the east elevation appears to be in good condition after 15 years in service. The expected life of roofing varies from less than 15 years to more than 25. The remaining life is assessed to be 5-15 years.

Recommendations: budget for future replacement; inspect and repair in the short term as a maintenance item.

(roof – replacement allowance: \$117,000; 2031; 25 year cycle)

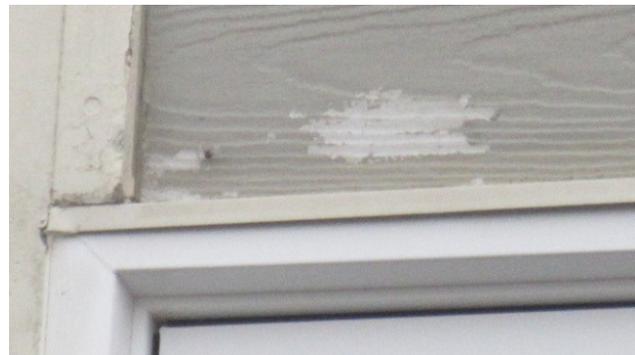
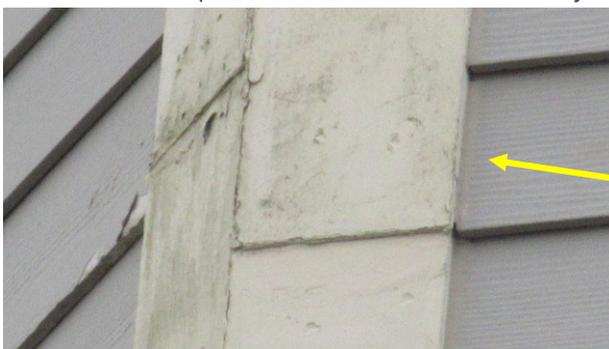
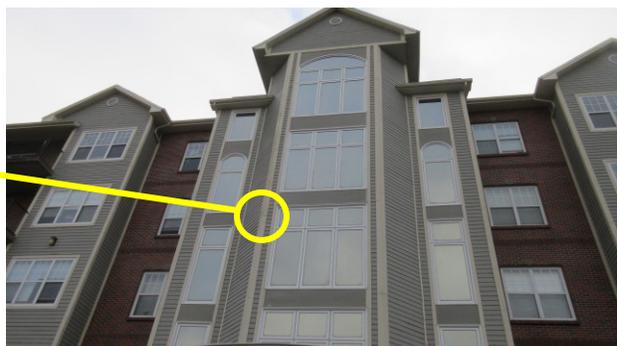
The horizontal lap siding is in good condition overall except locally in several areas where the manufactured coating has delaminated and water has been absorbed by the siding (photo). With local repairs and painting, the siding may be serviceable for 10-20 years.

Corner boards are in fair condition, with deterioration at the ends of boards in several locations (photos below – above main entry).

Recommendations: replace corner boards with vinyl boards at 2/3 of locations, and repair and paint the remaining siding and boards in the short-term; budget for replacement of all siding and boards with vinyl within ten years.

(exterior siding – refurbish west wall: \$36,000; 2020; (replace within a ten year cycle))
(exterior siding – replace west wall: \$200,000; 2027; 40 year cycle)

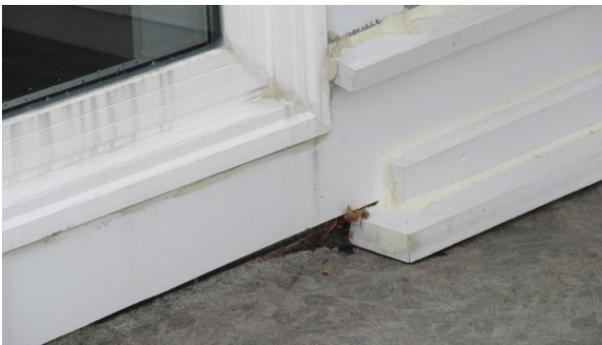
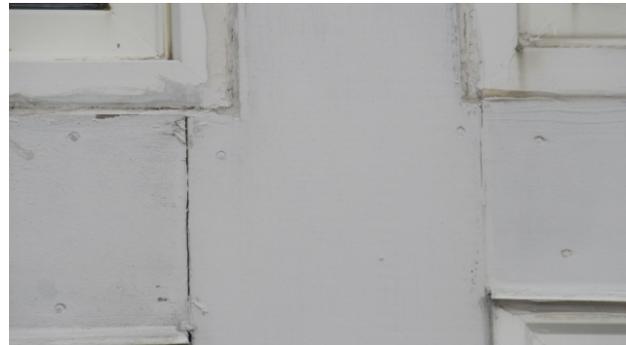
Assessment: The window wall systems appear to be in good condition overall and are assessed to have a remaining life beyond the evaluation period. The sunroom system is reported to have leaks at the vinyl-framed glazing units and/or wood framing (photo). The wood framing exterior finishes are in fair condition (photo).

Recommendation: replace four vinyl-framed fixed glazing panels in the sunroom, possibly with sliding or bi-parting doors, within the next three years; select the units for exposed conditions. Refinish exterior framing, possibly with sheet aluminum cladding, during replacements.

(sunroom fixed glazing – partial replacement: \$12,800; 2021; 30 year cycle)
